UNITED STATES ARMY AVIATION
CRASH INJURY RESEARCH

Final Report

TRECOM Technical Report 63-23

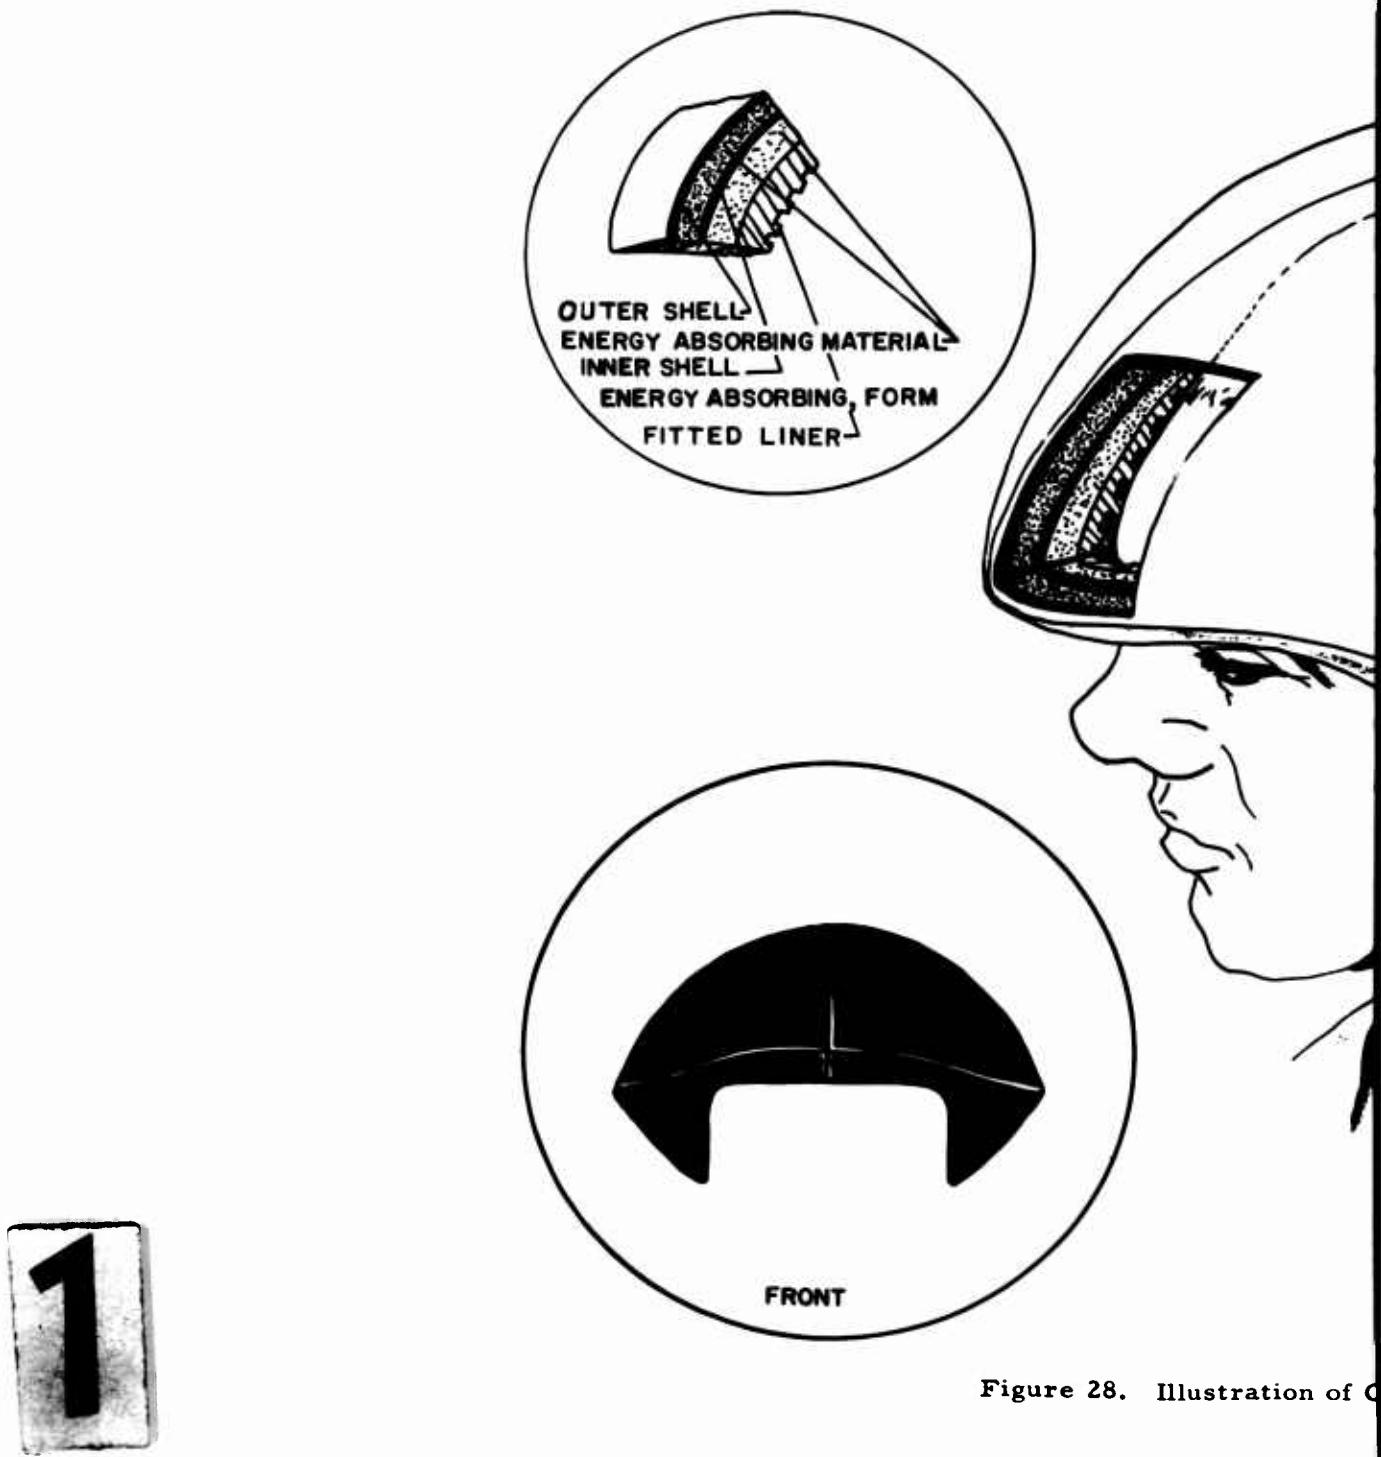
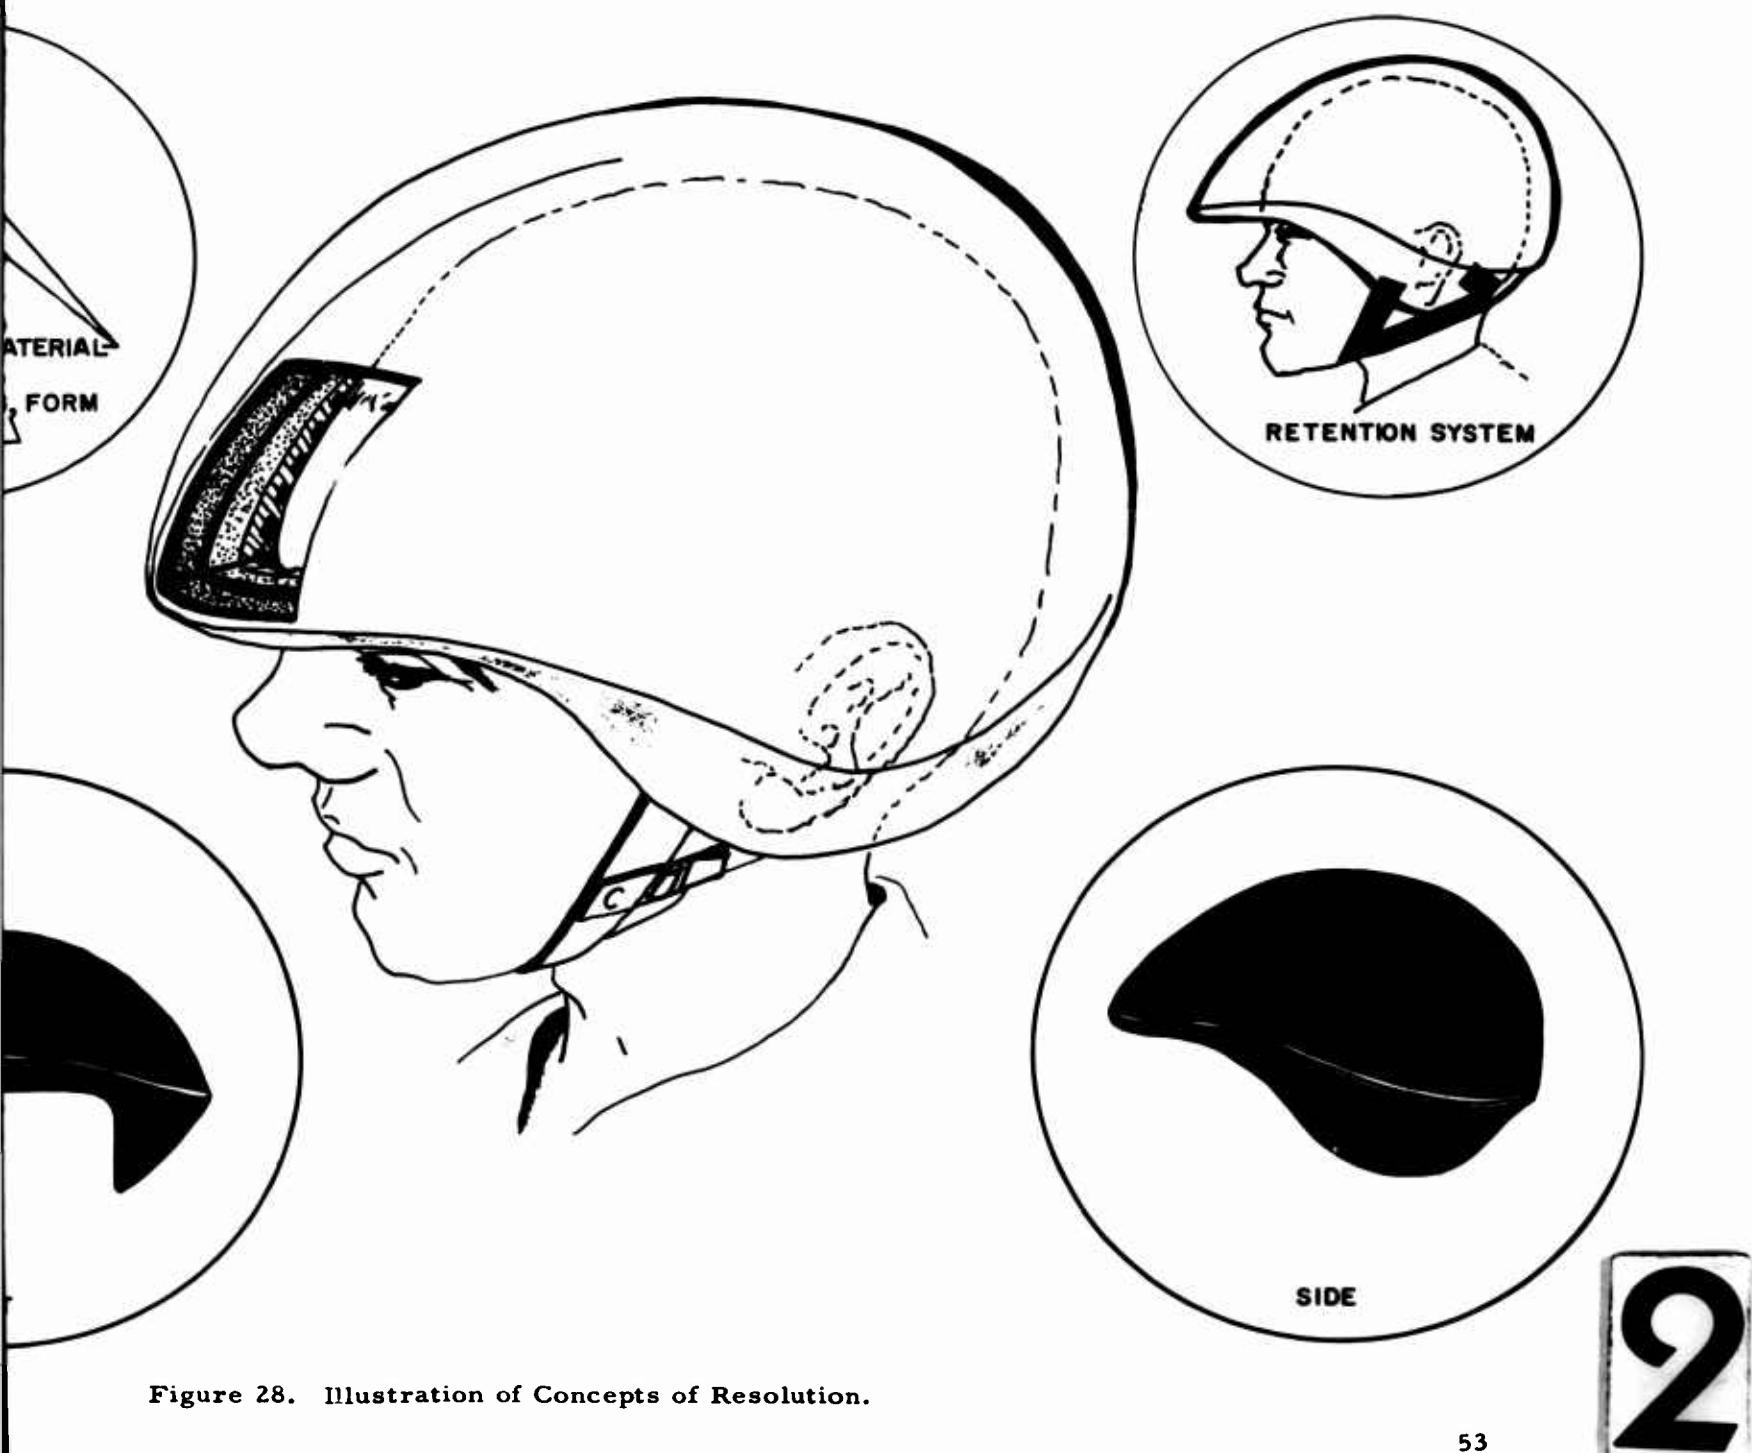
Figure 28. Illustration of Concepts of Resolution.

In this report, the APH-5 is used as a basis for study in the development of concepts for recommendations by which its deficiencies can be utilized in organizing thought for design of an ultimate head protective device (HPD). Figure 28 illustrates concepts of resolution of

A parabolical sequence build-up is recommended in lieu of the sphere presently used.

Screws, knobs, and specialized metal objects on the surface of the HPD serve as injury producers. Therefore, it is recommended that the helmet surface be kept clean and that all components be integrated into the unit structure.

A concept of a retention system is recommended whereby the helmet is secured by circumferential anchorage to the base of the head, applying retention to the chin and occipital-nuchal protuberances primarily, but facilitating these by tying them together.

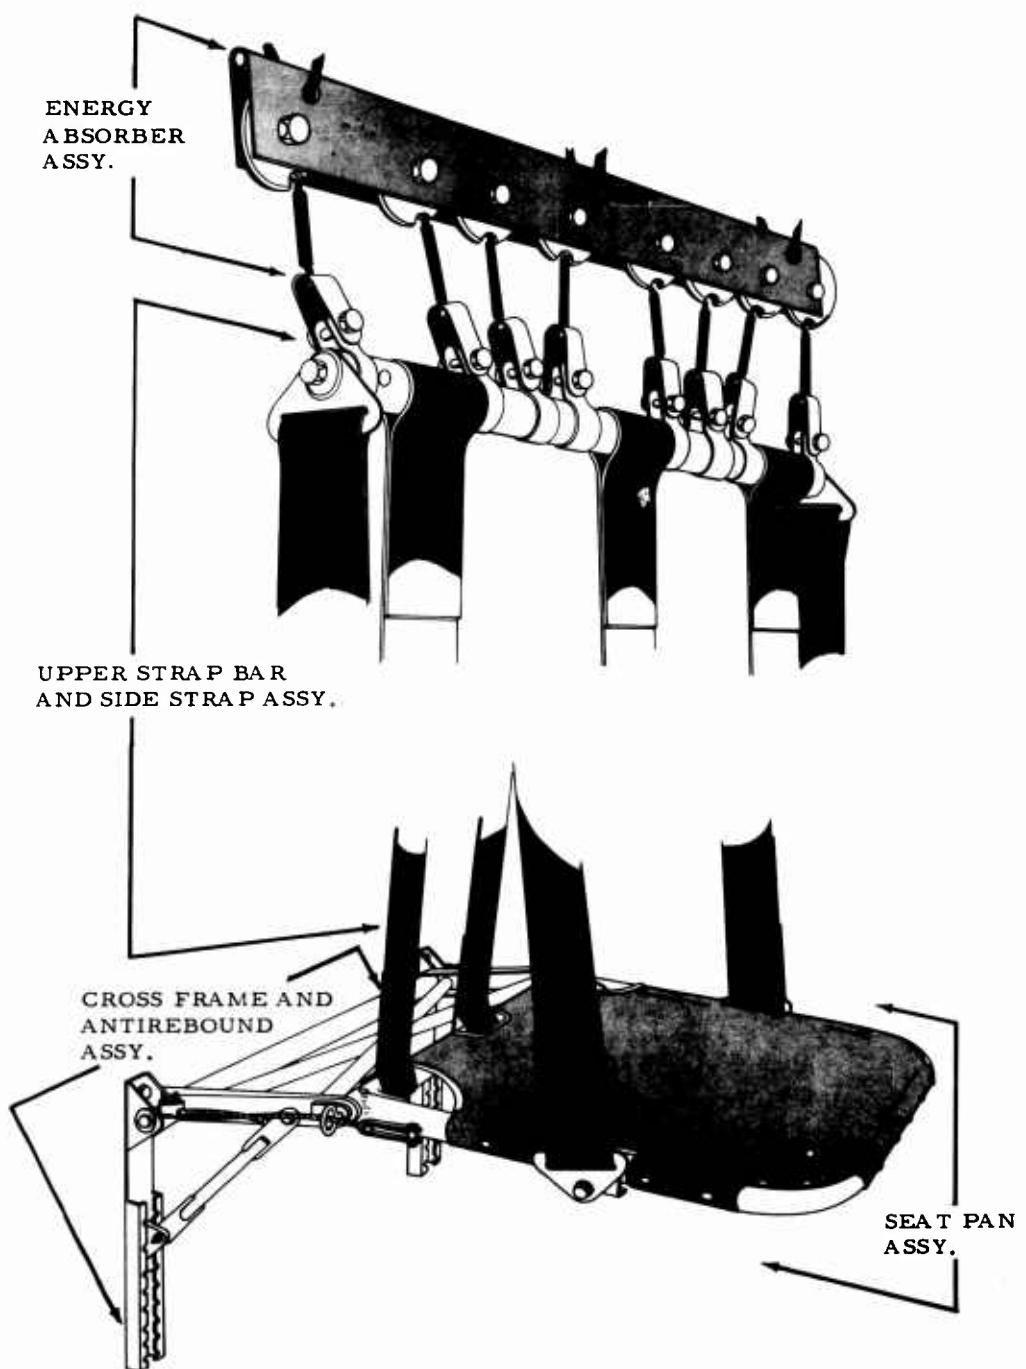
Figure 29. Seat Sketch Showing Assemblies.

A seat similar to the one used for the full-scale crash drop test conducted by AvCIR on 9 August 1961 (Figure 29) was tested at Wright-Patterson Air Force Base, Ohio, during the period 13 through 23 December 1961, utilizing a vertical deceleration drop tower. Three test programs were conducted. The first series of tests were conducted to determine the deformation rate for the energy absorbers used in the seat. This deformation rate was then used to compute drop heights for the initial seat drops. Twelve drops of single energy absorber and various weight combinations were conducted during this series. The second series of tests consisted of five drops of the seat itself, with the energy absorbing devices incorporated in the seat mechanism. The third series of tests consisted of six drops of the seat at increasing 5G increments, without the energy absorbers installed, until ultimate failure of the seat occurred.

1. The concept of the Hardman Mark III energy absorbing system be utilized in the design of all troop seats which are to be used in Army aircraft.
2. A new troop seat which incorporates the concepts of the Hardman Mark III energy absorbers be designed.

3. All future testing of seats include dynamic as well as static conditions.
4. The concept of attaching the seat to structure other than the floor be considered in future seat designs.
